Andrewes House

Barbican Estate

The City of London Corporation

External Fire Risk Assessment

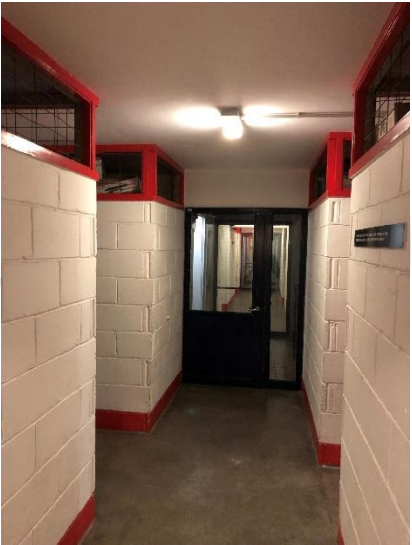
Resident Store Areas. The Level 03 tenant storage areas have potentially confusing exit routes and the directional and fire exit signage in the tenant storage areas is considered inadequate. Further to Action 2 It could not be conformed if the emergency lighting in these areas is adequate. It is understood that emergency lighting and exit signage will be improved by CoL to meet the current relevant standards. **See Action 2**

It is understood that emergency lighting and exit signage will be improved by CoL to meet the current relevant standards.						
3	<p>Planned Preventative Maintenance (PPM)</p> <p>No PPM / statutory inspection records were provided.</p>	<p>Ensure the maintenance of the following systems is up to date:</p> <ul style="list-style-type: none"> • Fixed Electrical Wiring (including Thermographic imagine where required) of all communal systems including plant rooms and lift motor rooms. • Emergency Lighting (and any back-up generator) • Dry Risers • Firemen's Lifts • Smoke Vents - Opening Vents (OVs) • Lightning Protection • Fusible Link activated Fire Shutters 		Medium	C		
4	<p>Compartmentation and Firestopping</p> <p>The previous fire risk assessment had identified</p>	As there are numerous compartmentation breaches, the service risers/electrical intake cupboards in all of the blocks at Andrewes House should be surveyed by a compartmentation/fire		Medium	D

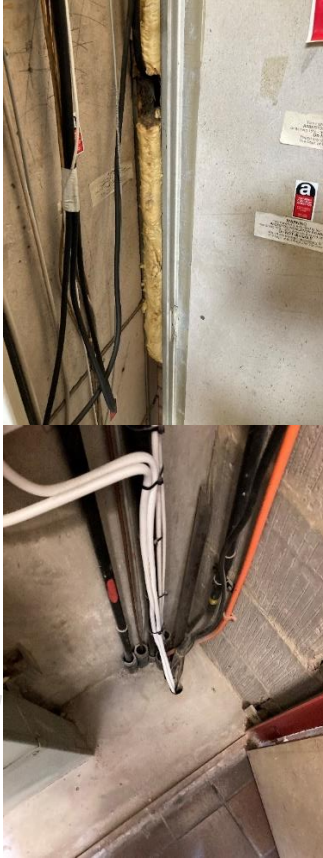
The previous fire risk assessment had identified compartmentation breaches in the main riser within the firefighting stairs and in the risers either side of the blocks where the flats open directly into the stair. Most of the defects are small holes around conduit which cables pass through. However, there are some much larger breaches particularly in the phone/Telcom risers where selections of the breeze block wall have been broken through to run services and the holes partially filled with expandable foam. From sample checks, no obvious fire stopping works appear to have been completed since the previous FRA. **See Action 4**

<p>compartmentation breaches in the main riser within the firefighting stairs and in the risers either side of the blocks where the flats open directly into the stair.</p> <p>Most of the defects are small holes around conduit which cables pass through. However, there are some much larger breaches particularly in the phone/Telcom risers where sections of the breeze block wall have been broken through to run services and the holes partially filled with expandable foam.</p> <p>From sample checks, no obvious</p>	<p>stopping specialist and where defects are identified they should be sealed with an appropriate proprietary fire stopping material to maintain 60 minutes fire separation/compartmentation between the riser and the common area/flat</p>

<p>fire stopping works appear to have been completed since the previous FRA.</p>

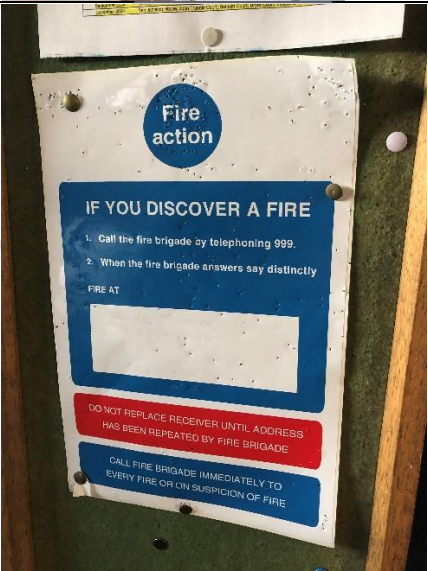
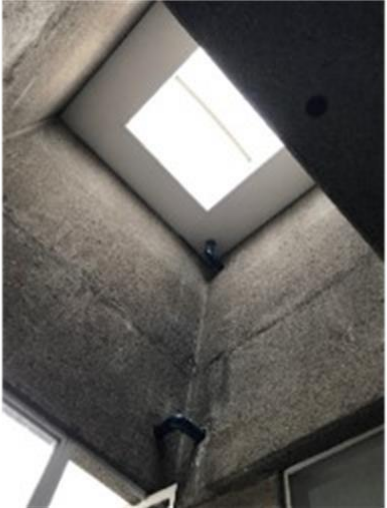
The other stairways are not ventilated other than by openable windows, however these windows cannot be opened internally so would provide little benefit in firefighting conditions. It appears there may have originally been Permanently Open Vents at the head of the stair but if so, they have been removed when windows at the head of the stairs were replaced.

<p>6</p>	<p>Smoke Ventilation</p> <p>There is no smoke ventilation at the head of the any of the single stairs (other than some windows that can be opened from the outside only or manually openable vents which are only present in the firefighting stairs). It appears that there could originally have been open vents at the heads of the stairways but if so that they may have been removed by new window installations. It's recommended in the Arup retrospective fire strategy for Andrew House that for escape purposes</p>	<p>Due to the height of the building, and because the flats open directly into the stairs, it is advised that AOVs are installed to provide 1m² of smoke ventilation at the heads of all the staircases from which the flats are accessed.</p>

<p>Automatic Opening Vents (AOVs) should be installed in all of the stairways.</p>						
<p>7</p>	<p>Smoke Ventilation</p> <p>Further to action 7 above, the smoke ventilation in the building appears to be below the expected levels.</p>	<p>It is advised CoL should commission an expert appraisal by a smoke ventilation specialist to consider the adequacy of the existing smoke control arrangements in the building, including any links to the car park.</p> <p>The smoke control appraisal should review the adequacy of the existing smoke control arrangements, their condition and any planned preventative maintenance regime. The appraisal should also consider if any additional smoke ventilation measures are required.</p> <p><i>NB – it is anticipated that such an appraisal may be considered necessary as part of the Safety Case required under the Building Safety Act 2022.</i></p>	<p style="font-size: 48pt; opacity: 0.5; text-align: center;">O L</p>	<p>Low</p>	<p>D</p>

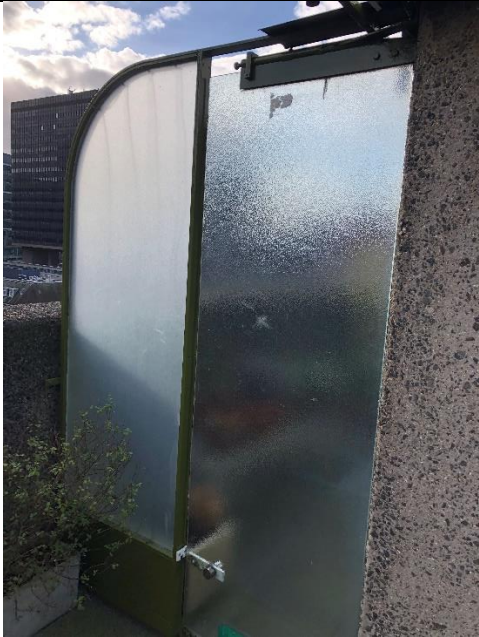
It is understood that there is no specific planned preventative maintenance regime for the glazed privacy escape doors/screen along the linking balconies. Weather conditions can affect the door and fixings, and therefore the ease of operation of escape device. **See Action 9**

compartmentation between the floors.						
9	<p>Privacy Screens on secondary means of escape.</p> <p>It is understood that there is no specific planned preventative maintenance regime for the glazed privacy escape doors/screen along the linking balconies. Weather conditions can affect the door and fixings, and therefore the ease of operation of escape device.</p>	<p>It is advised that a planned preventative maintenance regime is put in place to ensure that the glazed privacy escape doors/screens remain openable at all times i.e., fixings / bolts remain in a good and easily openable condition. It is recommended the doors are inspected at least annually.</p>

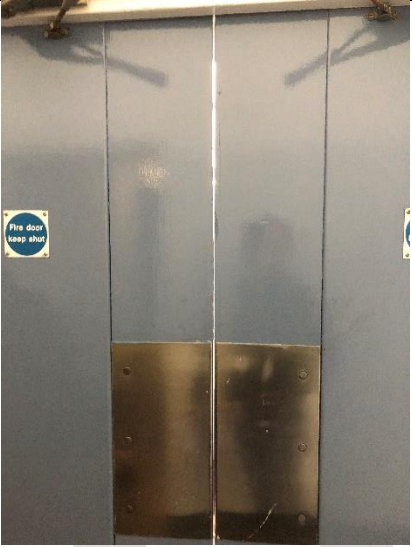
The fire doors / partitions protecting the firefighting stairs do not comply with current standards (which require 120 minute partitions with FD60S doors). These doors are considered to be notional fire doors only and are fitted with Georgian wired glass side panels. Several of these door sets have excessive gaps between the meeting edges. It is understood these doors will be replaced as part of the fire door replacement project. **See Action 13**

12	<p>Flat Entrance Doors - Self Closers</p> <p>Sample checks to the flat entrance doors identified that none are fitted with effective self-closing devices.</p>	<p>The existing flat entrance doors should be self-closing to minimise the risk of smoke entering the means of escape.</p> <p>All flat entrance doors must be fitted with effective self-closing devices (i.e. an overhead self-closer).</p>		High	C		
13	<p>Fire-fighting stairs</p> <p>The fire doors / partitions protecting the firefighting stairs do not comply with current standards (which require 120 minute partitions with FD60S doors). These doors are considered to be notional fire doors only and are fitted with Georgian wired glass side panels. Several of these door sets have excessive gaps between the meeting edges.</p>	<p>It is understood that the communal fire doors in the building will be replaced as part of the CoL/Barbican Estate, communal fire door replacement project.</p> <p>It is advised that FD60S doors are fitted with at least REI 60 rated side panels to the partitions that separate the firefighting stairs from the lift/accommodation lobbies.</p>		Medium	E

<p>It is understood these doors will be replaced as part of the CoL communal fire door replacement project.</p>

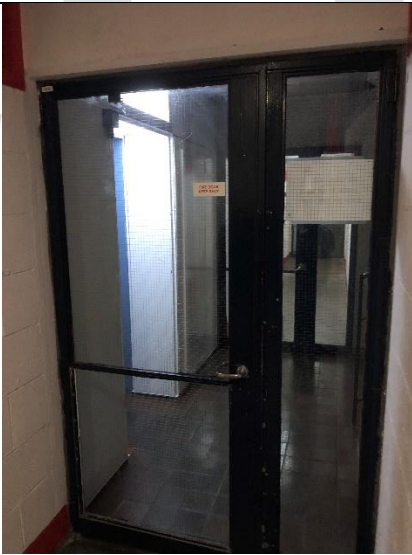
<p>14</p>	<p>Level 03 –Lobby Doors</p> <p>Fire door AMD106 which protects one of the stairs is not fully closing. The side ¼ door is stuck.</p>	<p>Ensure door AMD106 is repaired/adjusted so that it fully self-closes into its frame when released from any angle.</p> <p>Further to the fire door checks required under Action 9 above, confirm all doors protecting the stairways at level 03 are fully self-closing into their frames.</p>

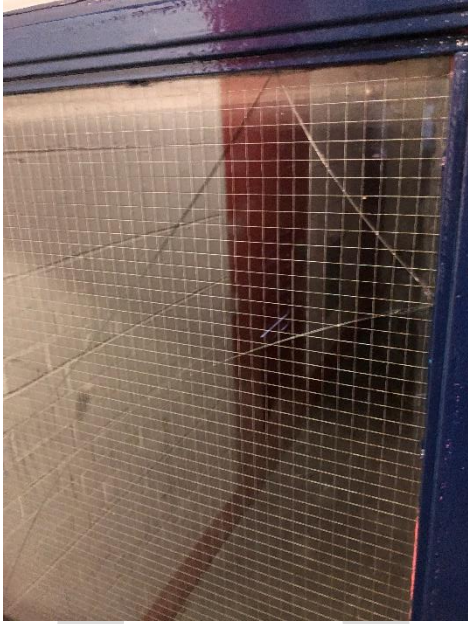
The wired glass door providing access to the service tunnel is cracked. This will affect the integrity of the door in a fire. **See Action 15**

<p>15</p>	<p>Level 03 – Service Tunnel Access</p> <p>The wired glass door providing access to the service tunnel is cracked. This will affect the integrity of the door in a fire.</p>	<p>The cracked wired glazing in the door should be replaced or over boarded with a material that will provide at least 30 minutes fire resistance.</p>

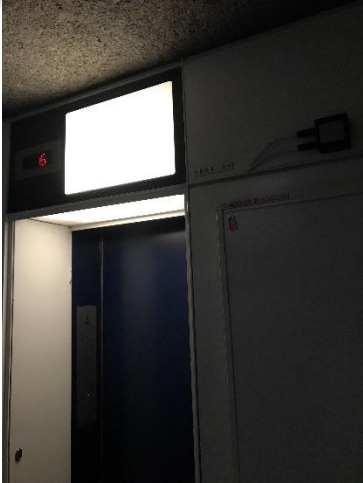
There are light fittings above the lifts. These lights are fitted with metal hoods that separate them from the risers. It was noted that several of these hoods had been displaced, effectively leaving an open hole between the risers and stairwell. **See Action 16**

<p>Low</p>	<p>D</p>	
<p>16</p>	<p>Lift Landing lights</p> <p>There are light fittings above the lifts. These lights are fitted with metal hoods that separate them from the risers.</p> <p>It was noted that several of these hoods had been displaced, effectively leaving an open hole</p>	<p>All of the lift landing lights should be checked to ensure that the metal covers are in place with no gaps. Where gaps are identified they should be sealed to ensure that there is at least 30 minutes imperforate compartmentation between the riser and lift lobby.</p>

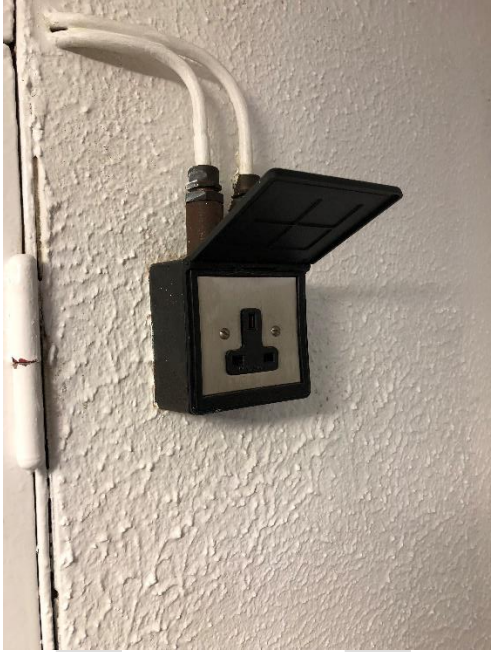
Non-secured 240v “power sockets” are located in the communal corridors – these can easily be used by residents to charge electric bikes, scooters, and mobility scooters which are a potential fire hazard and should not be charged in communal areas. **See Action 20**

Medium	D		
20	<p>Cleaners Sockets</p> <p>Non-secured 240v “power sockets” are</p>	<p>It is advised that the communal electric sockets are fitted with locks to prevent them being used by</p>		Advice	Advice

<p>located in the communal corridors – these can easily be used by residents to charge electric bikes, scooters, and mobility scooters which are a potential fire hazard and should not be charged in communal areas.</p>	<p>unauthorised persons, and specifically so they are not used to charge equipment which utilise Lithium-Ion Batteries, in communal areas.</p>

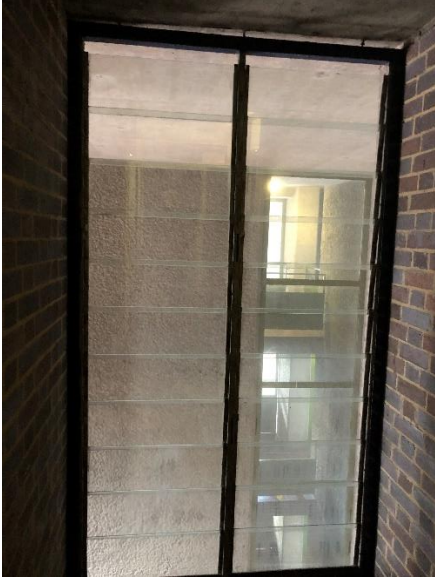
Louvered Smoke Vent – Block 185-192, Level -01 - Part of the louvered smoke vent does not open. The mechanism appears to be broken This smoke vent is for use of fire fighters. **See Action 25**

<p>25</p>	<p>Louvered Smoke Vent – block 185-192 level -01</p> <p>Part of the louvered smoke vent does not open. The mechanism appears to be broken This smoke vent is for use of fire fighters.</p>	<p>The louvered smoke vent / mechanism should be inspected and repaired as required to ensure the smoke vent can be opened.</p>

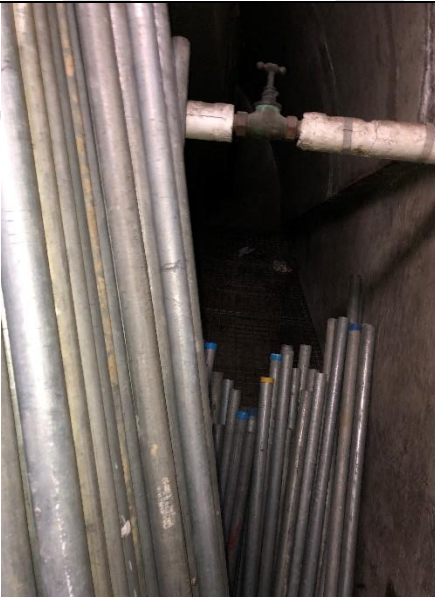
<p>Medium</p>	<p>C</p>	
<p>26</p>	<p>Storage obstructing top of smoke shaft</p> <p>At roof level the top of the smoke shaft and the louvered vented side to the wider enclosure is partially obstructed by access equipment (scaffold) etc.</p>	<p>Ensure staff and contractors who use this area understand the vents are a critical part of the smoke control system for this building, and the smoke vents must not be obstructed.</p> <p>This area should be managed to ensure smoke vents are kept clear.</p>
