Fire Risk Assessment

For Bayer House

Bayer House, Golden Lane Estate, London, EC1Y 0ST

ASSESSMENT REF. RB-2ELVKR

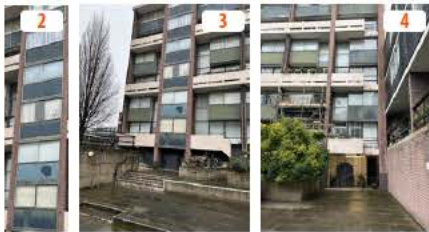
LOCATION External Façade

From what can be ascertained from a visual non-intrusive observation from ground level, the building appears to have an external wall system (e.g., cladding, insulation) or "specified attachments" which could potentially increase the risk of external fire spread. The fire risk appraisal of the external walls and any cladding is excluded from the scope of this current fire risk assessment, as this is outside our expertise and/or there is insufficient information available. Accordingly, it is strongly recommended that you obtain advice from qualified and competent specialists on the nature of, and fire risks associated with, the external wall construction, including any cladding, of this building. This exclusion is consistent with advice provided by The Fire Industry Association and is discussed in their guidance note to fire risk assessors on this matter (<https://www.fia.uk.com/news/guidance-on-the-issue-of-cladding-and-external-wall-construction-in-fire-risk-assessments-for-multi-occupied-residential-premises.html>). This assessment by specialists should be carried out in accordance with PAS 9980."

In one section of the building an external wall system runs vertically with no external breaks between flats. It was not possible to confirm if there is a cavity behind these panel and a potential route for fire to pass between flats. No information provided to verify if this has been checked. The panels in the façade appear to be wired glazing which has been over painted.
