Ben Johnson House

Barbican Estate

External Fire Risk Assessment

Prepared by: Turner & Townsend

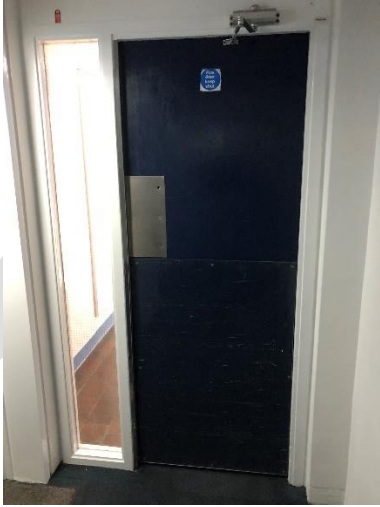
Fire doors to the stairway lobbies and stairs were generally found to be warped and/ or have ineffective self-closers. Some of the doors are fitted with “slam pads” which prevent the doors fully closing and are likely to have warped the doors over time. It is understood that City of London plant to replace all the communal fire doors, including riser doors, with certified fire door sets. **See Action 1**

Several of the communal fire doors separating the accommodation corridors from the stairway lobbies are in poor condition, and/or are warped, and/or are not fully self-closing into their frames.

<p>It is understood that City of London plant to replace all the communal fire doors, including riser doors, with certified fire door sets.</p>	<p>month fire door check required under the Fire Safety (England) Regulations.</p>					
2	<p>Emergency Lighting</p> <p>The emergency lighting in the building appears to be provided by a mix of self-contained units and “Standby Lighting” (as defined by BS5266 Part 1) with an alternative power supply provide by a generator. It was not possible to confirm the full locations of the standby units and the adequacy of</p>	<p>It is advised that a site wide survey should be undertaken of the stand by emergency lighting systems in the building (and along external means of escape) by a competent person, to assess their adequacy with a “gap analysis” between the as installed standards and those required by BS5266 Part 1 2016.</p>		Medium	D

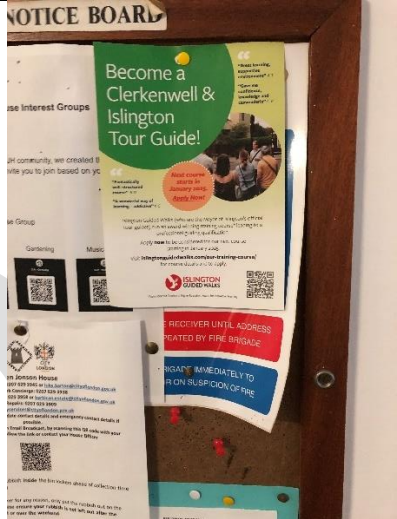
Fire Action Notices The Fire Action Notices do not describe the Stay Put strategy. At least one Fire Action Notice was partially obstructed by other notices. **See Action 4**

<p>4</p>	<p>Fire Action Notices</p> <p>The Fire Action Notices do not describe the Stay Put strategy.</p> <p>At least one Fire Action Notice was partially obstructed by other notices.</p>	<p>The Fire Action Notices should be replaced with signs that describe the Stay Put Strategy.</p> <p>Fire Action Notices should at least be displayed at all the entrances to the building.</p> <p>It is understood this will be completed as part of the CoL signage project.</p> <p>Ensure Fire Action Notices are displayed at all entrances to the building and that all Fire Action Notices are visible and not obstructed by other notices.</p>

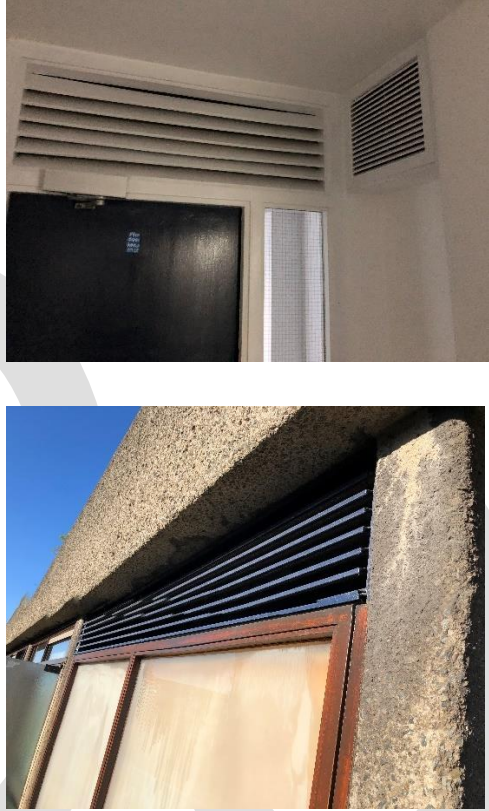
It is not known if the arrangement of Permanently Opening Vents in the corridors and lobbies would be effective. It could also not be confirmed if the vents have been periodically cleaned / maintained. **See Action 5**

<p>Opening Vents in the corridors and lobbies would be effective. It could also not be confirmed if the vents have been periodically cleaned / maintained.</p>	<p>smoke control in this building.</p> <p>The smoke control appraisal should review the smoke control systems adequacy (i.e. Permanently Opening Vents), condition and the planned preventative maintenance regime.</p> <p><i>NB – it is anticipated that such an appraisal may be considered necessary as part of the Safety Case required under the Building Safety Act 2022.</i></p>

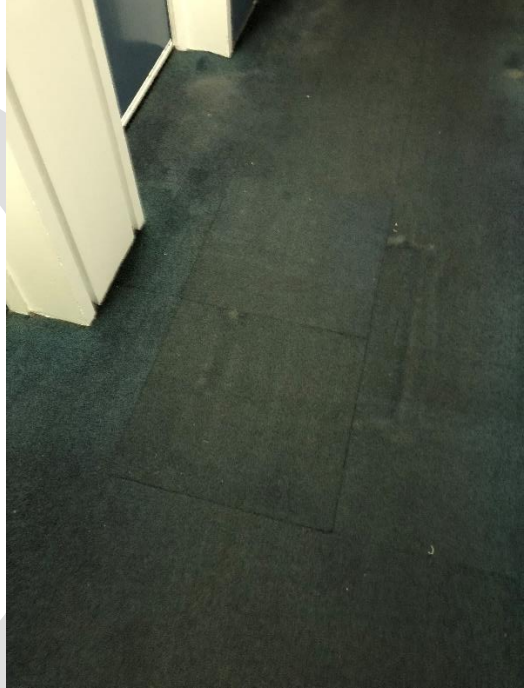
<ul style="list-style-type: none"> Lightning Protection 					
12	<p>Floor Voids along the accommodation corridors.</p> <p>No floor voids were accessed. It could not be confirmed if there is adequate compartmentation in any floor voids.</p>	<p>It is advised that sample checks are completed in any floor voids along the corridors to confirm that there is imperforate compartmentation between these voids and flats.</p>

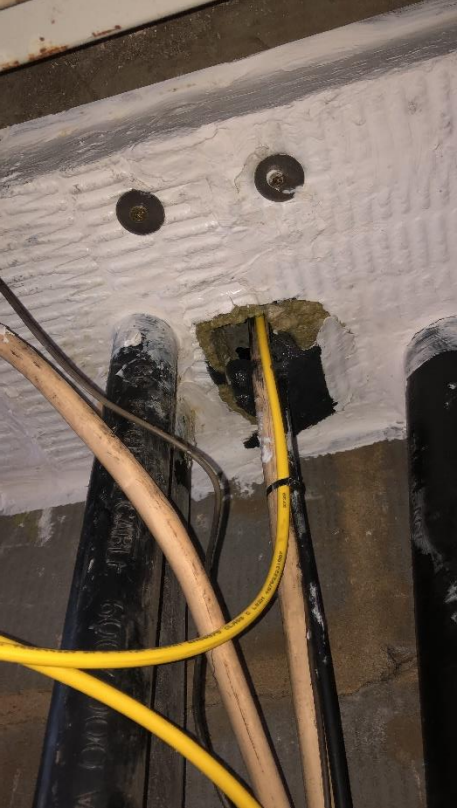
Lift landing lights - There are light fittings above the lifts. In some areas there is no/inadequate separation between the riser and light so there is effectively no compartmentation between the riser and lobby. **See Action 13**

Low	D		
13	<p>Lift landing lights</p> <p>There are light fittings above the lifts. In some areas there is no/inadequate separation between the riser and light so</p>	<p>Where gaps are identified they should be sealed to ensure that there is at least 30 minutes imperforate compartmentation between the riser and lift lobby.</p>		Low	D

<p>there is effectively no compartmentation between the riser and lobby.</p>	<p>Also, check and ensure any services running from the riser into the lobby ceiling void have been fire stopped using appropriate proprietary materials.</p>					
<p>14</p>	<p>Damage to new fire stopping</p> <p>Fire stopping had recently been completed in the lift riser cupboards accessed from the lobbies. In some risers it appears that telecoms cables have been pushed through the fire batt and not sealed.</p> <p><i>This was escalated to the Col Health & Safety Lead during the assessment.</i></p>	<p>It is advised that CoL review their contractor / access control arrangements to ensure contractors are not damaging fire stopping, or if they do so, any penetrations are suitably fire stopped.</p> <p>Where the fire batt has been damaged it should be repaired to achieve a minimum of 60 minutes fire resistance.</p>

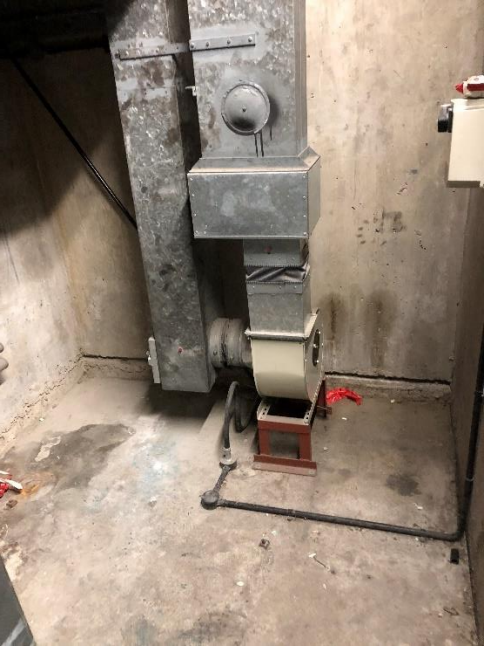
The building is fitted with a communal ventilation system(s). It is understood that these systems link between all flat bathrooms and kitchens and are therefore a potential source of smoke/fire spread between flats. It could not be confirmed if suitable shunt ducts or dampers are fitted in the system and maintained. **See Action 18**

<p>18</p>	<p>Communal ventilation system – The building is fitted with a communal ventilation system(s). It is understood that these systems link between all flat bathrooms and kitchens and are therefore a potential source of smoke/fire spread between flats. It could not be confirmed if suitable shunt ducts or dampers are fitted in the system and maintained.</p>	<p>It is advised that a survey of the communal ventilation systems is undertaken by a competent person to appraise whether the system incorporates suitable features to restrict the risk of smoke spread between flats, and whether any remedial measures are necessary.</p> <p><i>NB – it is anticipated that such an appraisal may be considered necessary as part of the Safety Case required under the Building Safety Act 2022.</i></p>

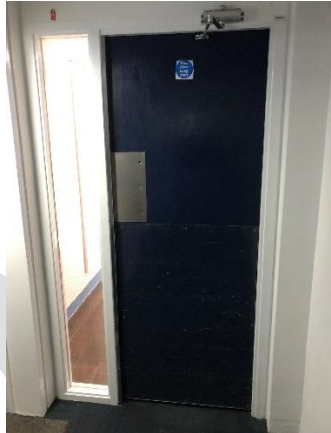
Corridor Fire Door – there is a hole in the door which could allow smoke to pass through. The hole the result of a missing fastening on the push plate. **See Action 24**

<p>24 Corridor Fire Door, No. Benjo 018</p>	<p>There is a hole in the corridor fire door which could allow smoke to pass through. It is due to a missing fastening on the push plate.</p>	<p>Seal the hole in the door with a material that provides at least 30 minutes fire resistance.</p>
