Fire Risk Assessment

For Black Raven Court

Black Raven Court, 103 Golden Lane, London, EC1Y 0TZ

ASSESSMENT SCOPE
This is a Type 1 Fire Risk Assessment and has been carried out in accordance with BS 9792:2025.

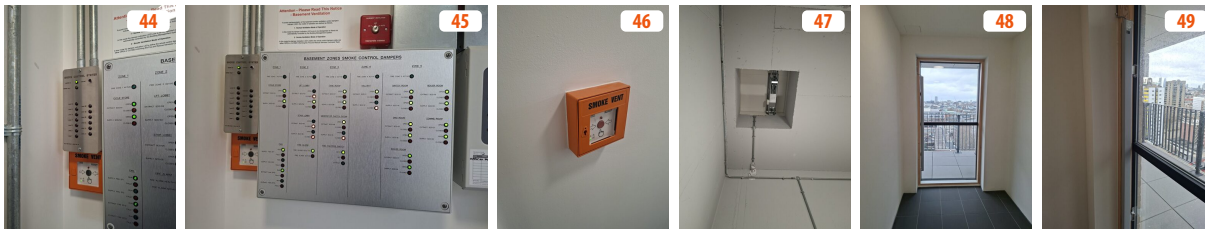
The case protecting the smoke vent override switch on the 4th floor is damaged. The lid appeared defective and had blu-tack applied in an apparent attempt to keep it shut. However, when checked, the lid popped open by itself, so is not secure.

The smoke vent control case should be properly repaired or replaced so it can be kept shut and secure, to restrict inappropriate activation or damage.

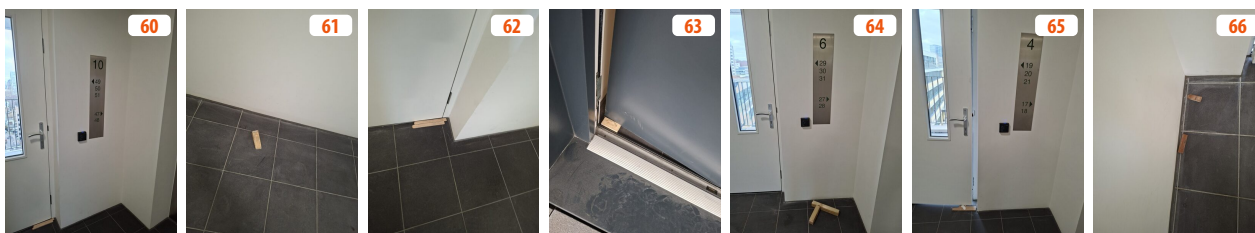
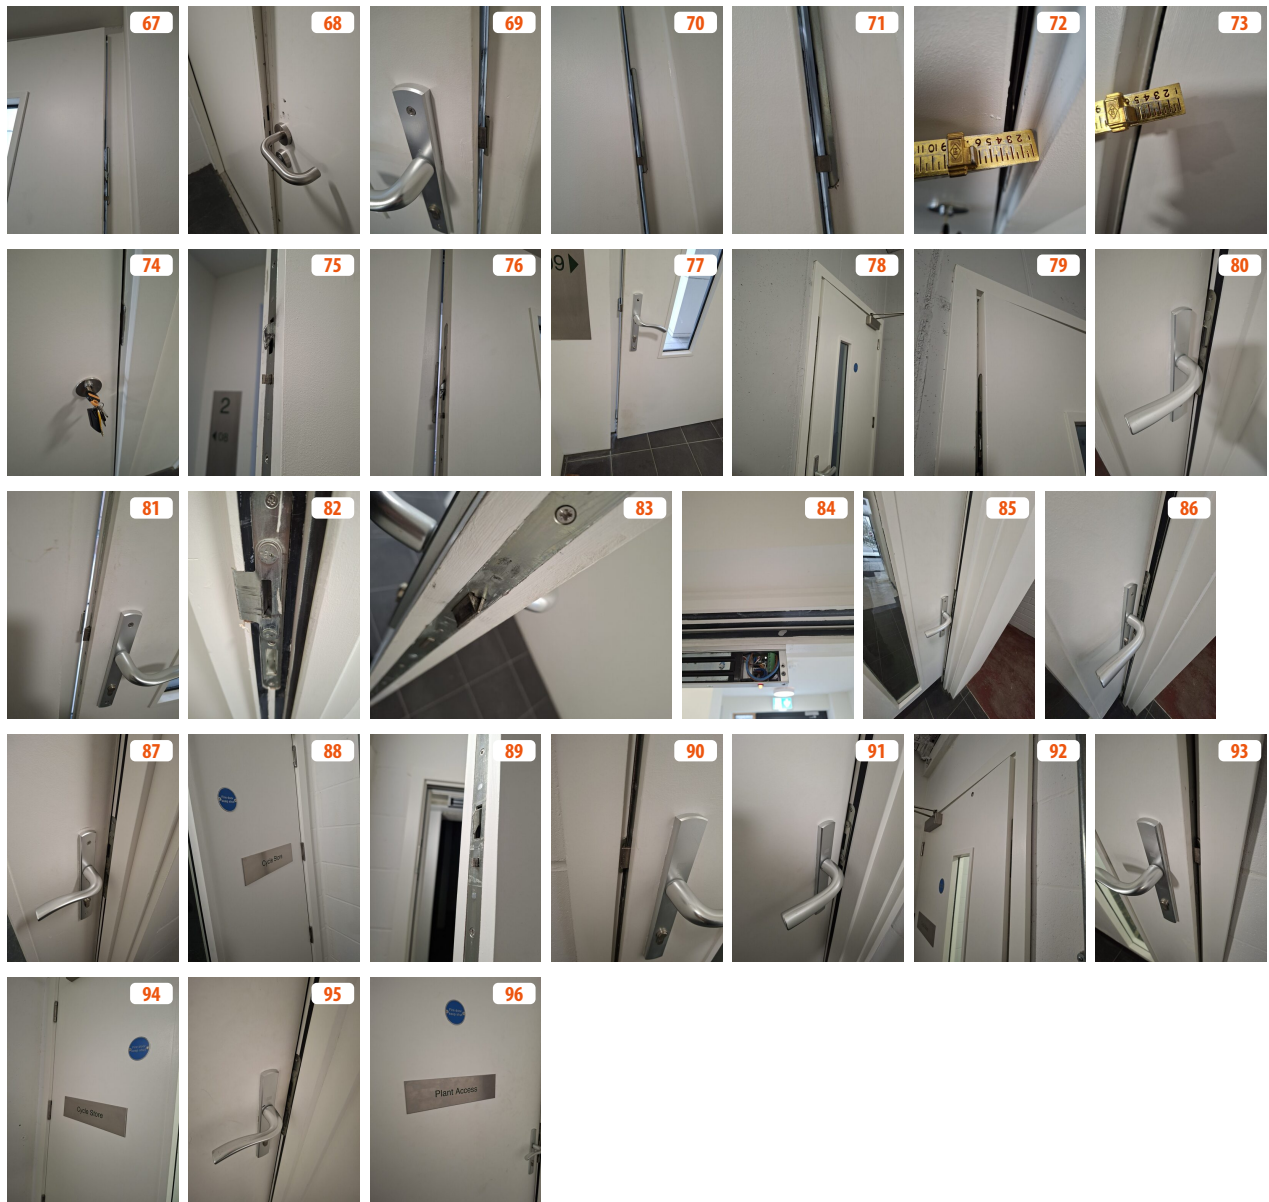
Several deficiencies were identified in relation to the communal fire doors throughout the building.

At 13th floor level, the door to the balcony, when held open after use of the fob, re-engages its lock after approximately five seconds. When released, this prevents the door from fully engaging within the frame and sitting flush. The latch was also noted to be stiff, hindering proper closure within the frame.

At ground floor level, the fire door from the staircase to the entrance lobby, when operated using the open button, required two attempts before the lock disengaged. The frame appeared slightly damaged. In addition, the magnetic lock cover to this door was missing, with exposed cabling visible.

Within the basement, the cycle store door, when held open, re-engages its lock, preventing it from closing properly within its frame. The storage room door within the cycle store did not sit flush within its frame. The same issue was noted with the plant room door and the sprinkler pump room door.

The identified fire doors should be inspected by a competent person. Unsure the fire doors and door furniture are rectified as appropriate to ensure the doors fully self-close into their frames, at a safe and controlled speed and when released from any angle.

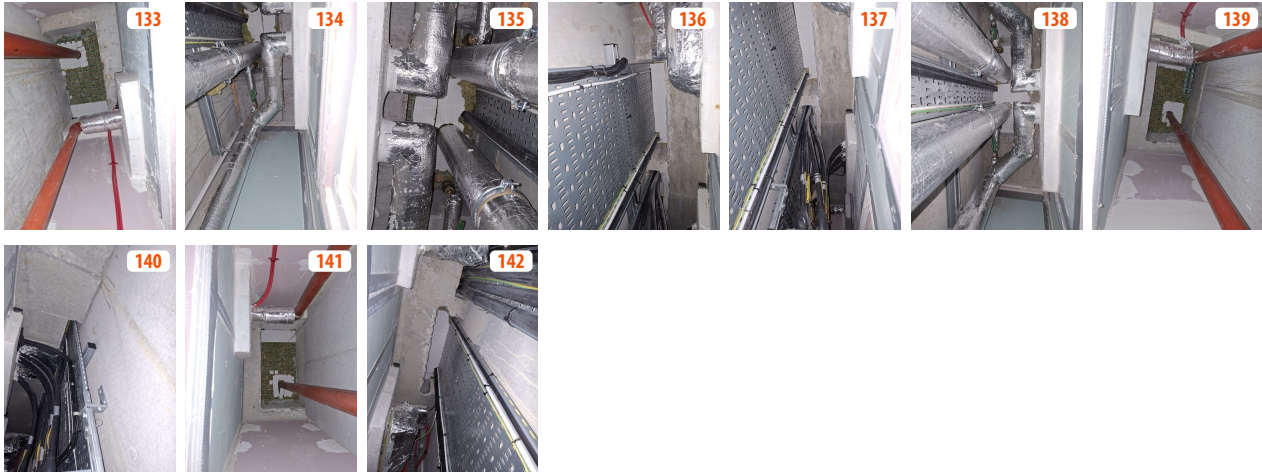
Significant damp and mold were noted at the base of the partitions in the risers, affecting both sides of the plasterboard and adjacent cupboards. It appears that fire-stopping installed between floors may have compromised ventilation within the risers, causing this problem. Prolonged damp and associated mold growth may have affect the long-term integrity of the compartmentation as the plasterboard degrades.

Arrange for a competent person to investigate the cause and extent of the damp and mold within the risers. Where advised by the competent person, ventilation should be improved but ensure any ventilation arrangements do not compromise the compartmentation or riser fire doors. Any damaged plasterboard or fire resisting materials should be replaced with appropriate fire resisting materials.
