Cromwell Tower

Barbican Estate, EC2Y 8DA

External Fire Risk Assessment

Prepared by: Turner & Townsend

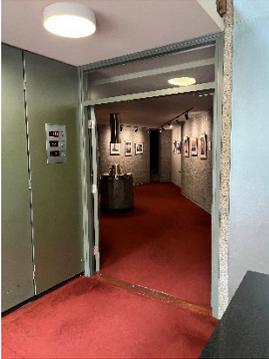
14.	The fire doors into the lift lobby and into the caretaker's room at L01 were propped open which could allow the spread of smoke and flames into escape routes and protected lobbies.	The Porters should be instructed to keep these fire doors closed and any door wedges disposed of. The carpark door hook should also be removed. Alternatively, as a long-term solution, these doors should be fitted with hard wired hold open devices linked to automatic detection in compliance with BS7274 Part 4 2015.

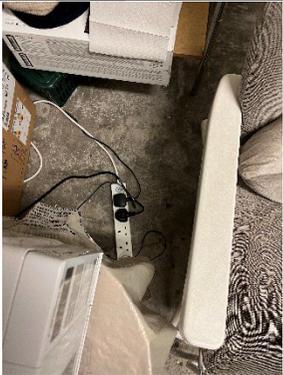
Items in the caretaker room located behind reception were observed to be missing PAT stickers or out of date. **See action 15.**

Medium	B		
15.	Whilst some appliances have up to date PAT labels, some appliances checked have no labels or what appear to be out of date labels.	Confirm that all portable appliances are subject to an appropriate inspection regime in accordance with CoL policy and HSE guidance. Reception desk – cables should be rationalised / tidied up and ensure

appliances have been PAT tested.

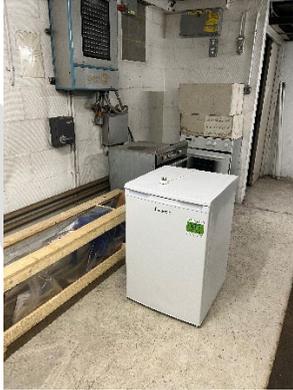
Numerous white goods and other combustible items were observed being stored in the electrical switch room. **See action 16.**

16.	There are what appear to be redundant white goods stored in Switch Gear 3A.	It is advised that redundant appliances should be removed from site and appropriately disposed of to minimise any unnecessary fire loading. Switch gear room should not be used for storage.

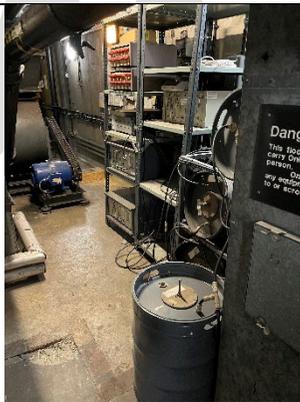
Low	D		
17.	There was no evidence to confirm that 3 rd party telecoms equipment noted in the Ventilation Plant areas and stairway electrical riser (EDA) is under an appropriate inspection and test regime	CoL should have arrangements in place to confirm that where 3 rd parties (e.g. Telecoms) have electrical equipment (or other work equipment) installed within the building, that the equipment is subject to an appropriate maintenance regime.

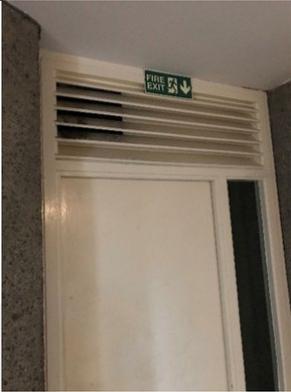
<p>18.</p>	<p>L39 Lift Lobby Ventilation</p> <p>The lift lobby is ventilated by a permanently open vent (POV) above the exit door to the stairway. It appears that this vent has been partially blocked up. It is understood that the vent is necessary as this is the top accommodation floor, so cannot be ventilated by opening balcony escape doors.</p> <p>There is only one flat opening lift lobby at this level so the risk is considered low and should be partially mitigated by the installation of an FD60S self-closing flat entrance door.</p>	<p>It is advised that the original ventilation to the top accommodation floor is reinstated to return to the original standard of construction.</p> <p>If a POV is deemed undesirable, then consider the viability of installing an automatic opening smoke vent (AOV) which would only open on activation of automatic smoke detection which would need to be installed in the flat access lobby.</p>

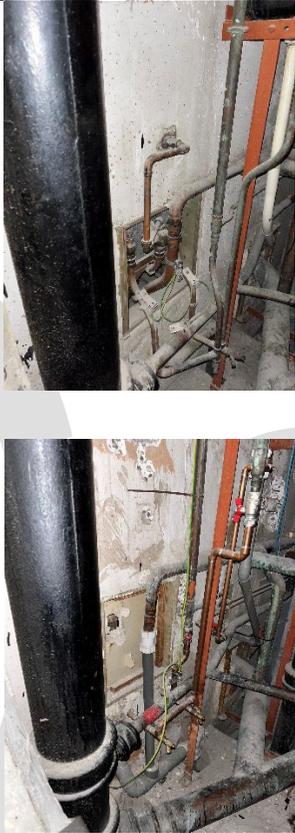
- In several of the bathroom risers (PDA) it was noted that plumbing works have penetrated the compartment walls and floors with no, or inadequate, remedial fire stopping works completed. This could potentially facilitate smoke spread between both the flats and the floor levels. There also appear to be some inadequately fire stopped service penetrations in the stairway riser (EDA) and in the electrical cupboards at, podium level, ground, and levels 01,02 & 03.
- It is understood that City of London have previously identified the compartmentation defects and have commissioned a specialist to complete a compartmentation survey at Shakespeare Tower (of similar design) to provide a specification for remedial works. **See action 19.**
- [REDACTED]
[REDACTED] **See action 21.**

<p>19.</p>	<p>In several of the bathroom risers (PDA) it was noted that plumbing works have penetrated the compartment walls and floors with no, or inadequate, remedial fire stopping works completed.</p> <p>This could potentially facilitate smoke spread between both the flats and the floor levels.</p> <p>(Note CoL confirmed that where recent and ongoing plumbing works take place, the penetrations are sealed with double plaster board to achieve 60 minutes fire resistance).</p> <p>There also appear to be some inadequately fire stopped service penetrations in the</p>	<p>Ensure that compartmentation defects identified in the risers are sealed/fire stopped with appropriate proprietary substances in accordance with the remedial works specification so that there is a minimum of 60 minutes fire separation between the flats and the riser, and at floor/ceiling levels within the riser.</p> <p>This should include bathroom risers, stairway riser and electrical cupboards located on the Podium levels, reception area, and levels 01-03</p>

<p>stairway riser (EDA) and in the electrical cupboards at Podium Level at ground level and levels 01,02 & 03.</p> <p>It is understood that City of London have previously identified the compartmentation defects and have commissioned a specialist to complete a compartmentation survey at Shakespeare Tower (of similar design) to provide a specification for remedial works.</p> <p>.</p>						
--	--	--	--	--	--	--	--

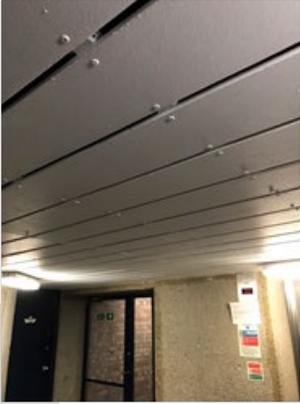
<p>20.</p>	<p>Ceiling Voids</p> <p>In some areas of the towers e.g., stairway landings, lower-level lift lobbies, there are false ceilings with cables running in them. The ceiling material appears to be a composite material (e.g., Asbestos/ACM)) rather than timber, though this could not be confirmed, and it was not possible to confirm that cables in the void are appropriately secured.</p>	<p>CoL should confirm that:</p> <ul style="list-style-type: none"> • The ceiling material is non-combustible. • The paint is rated B-s3, d2 for surface spread of flame. • Any cables are above the false ceiling suitably secured with fire rated fixings. • Where any cables in the ceiling void pass through a compartment wall or ceiling that they are appropriately fire stopped.

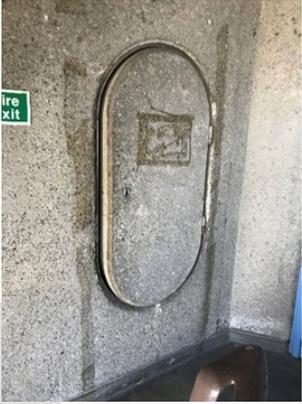
<p>21.</p>	<p>[REDACTED]</p> <p>This compromises the compartmentation between the risers and the lift lobbies.</p>	<p>Ensure all bathroom riser access doors are kept locked shut and any broken locks are repaired/replaced as required.</p> <p>These doors should be routinely monitored to ensure that they are kept locked shut.</p>

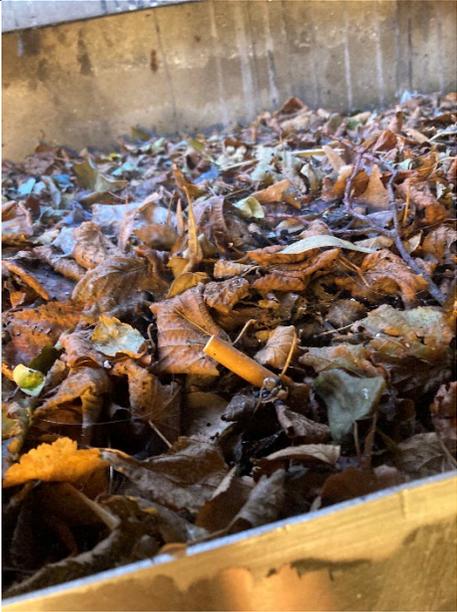
35.	<p>External, ventilation shaft between carpark and Cromwell house.</p> <p>Leaves have accumulated on top of the ventilation grill. There is as evidence of smoker materials (from street level) being dropped into this area.</p>	<p>The ventilation grill between these two areas should be regularly cleaned to prevent a build up of leaf litter and any other combustible rubbish.</p>

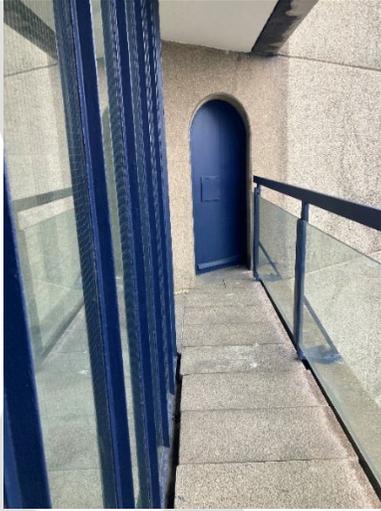
Where necessary the door should be added to the list of common area fire doors which should be regularly inspected.					
38.	On the external escape balconies some of the exits from the flats (believed to be the kitchen exit) may have been overpainted which could make it difficult for these exit doors to be opening internally from within the flat.	CoL should inspect these exits from the kitchens of the flats onto the external balconies to determine if overpainting of these exit doors would make them difficult to open in an emergency. Where necessary measure will need to be implemented to ensure these exit doors are immediately openable.
