Ben Johnson House

Barbican Estate

External Fire Risk Assessment

Prepared by: Turner & Townsend

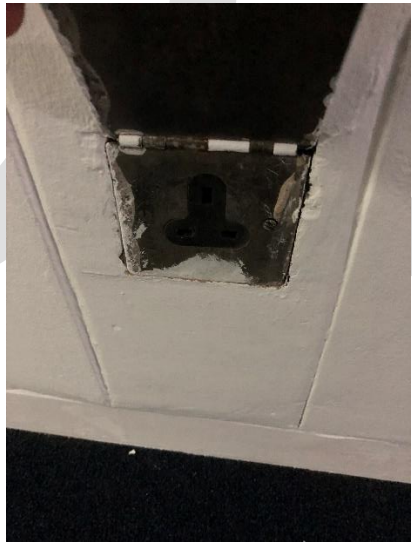
Non-secured 240v “power sockets” in common lobbies – these can easily be used by residents to charge electric bikes, scooters, and mobility scooters which are a potential fire hazard and should not be charged in communal areas. **See Action 21**

<p>cognitive or physical impairments).</p> <p>There are no specific physical provisions in the building for Persons with Restricted Mobility. The need for such provision may need to be reviewed in accordance with the new legislation.</p>					
21	<p>Cleaners Sockets</p> <p>Non-secured 240v “power sockets” for use by the cleaners are located in the communal corridors – these can easily be used by residents to charge electric bikes, scooters, and mobility scooters which are a potential fire hazard and should not be</p>	<p>It is advised that the communal electric sockets are fitted with locks to prevent them being used by unauthorised persons, and specifically so they are not used to charge equipment which utilise Lithium-Ion Batteries, in communal areas.</p>
