Fire Risk Assessment

For Black Raven Court

Black Raven Court, 103 Golden Lane, London, EC1Y 0TZ

ASSESSMENT SCOPE
This is a Type 1 Fire Risk Assessment and has been carried out in accordance with BS 9792:2025.

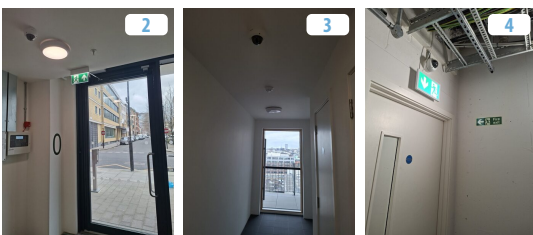
The premises is installed within CCTV covering internal and external areas.

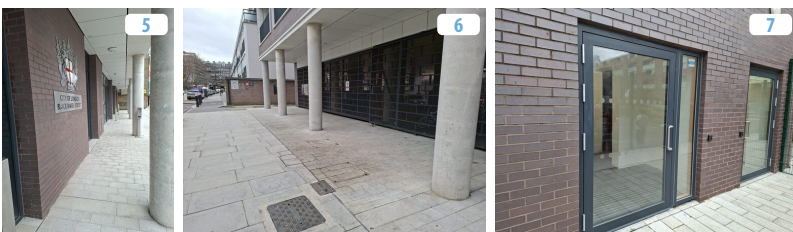
No significant combustible materials / waste stored in close proximity to the building.

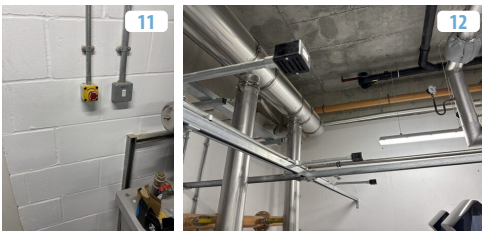
Manual and fusible link type automatic gas shut off devices are installed in the Boiler Room.

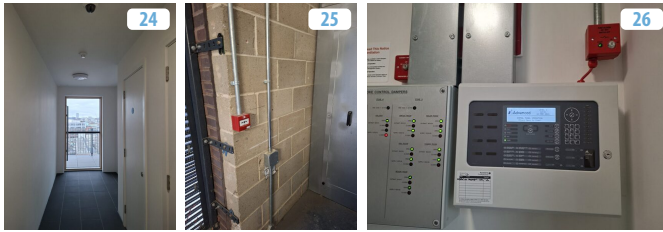
The premises appears to be fitted with a communal L5 system per BS5839 Part 1 covering the communal residential areas, ancillary accommodation, and commercial units. Fire alarm panel in main residential entrance with detection only in residential lobbies and stairway (for AOV activation). Detection and sounders in the ancillary accommodation and commercial units. Sounders in plant rooms, roof and ancillary areas only (to facilitate simultaneous evacuation from these areas). Manual call points at all final exits and on roof.

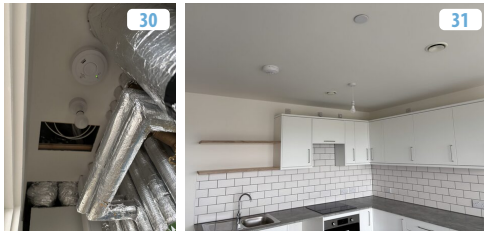
Flats are Grade D1 LD1 fire alarm systems per BS5839 Part 6. These consist of interlinked hard-wired detection with heat alarms in kitchens (and covering lounges of open plan flats) with smoke alarms in hallways, landings, bedrooms, consumer unit/heat recovery unit cupboards and lounges of maisonettes.

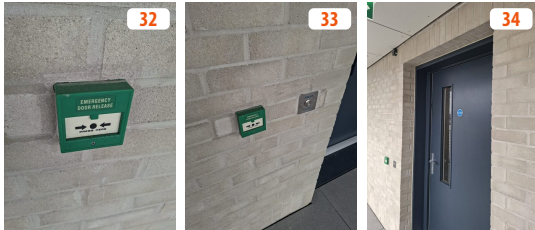
REFERENCE RB-FC955Z DUE 12/06/2026

There are final exits via the front and rear entrances to the residential demise. There is a separate exit from the basement to the rear of the building and, with a secondary means of escape from the plant room corridor via a pit and cat ladder.

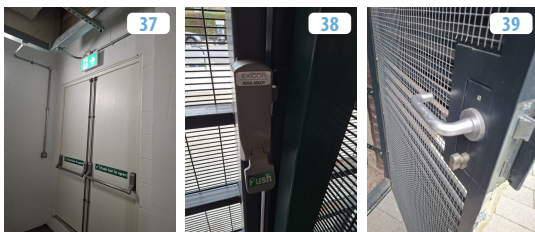
The number and door release hardware and were immediately openable.

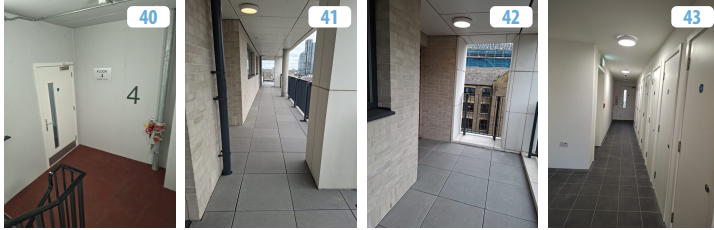
Any storage seen along the approach balconies (including plants / planters) was considered tolerable. A clear width of approximately 1m was being maintained for escape purposes.

The means of escape and final exits were unobstructed.

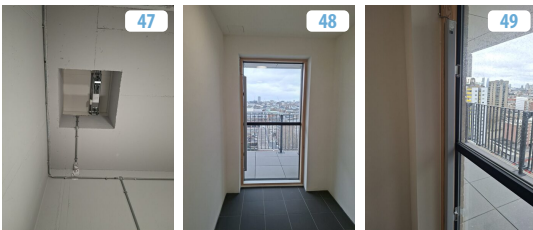
Automatic Opening Vents (AOV) are fitted to provide 1.5m² of smoke ventilation in each firefighting lobby. An AOV is fitted at the head of the stair to provide 1m² of smoke ventilation to the stair.
To minimise the risk of smoke compromising the stairway.

The firefighting stair is lobby protected. Each lobby is designed to provide 120-minute fire protection to the firefighting stair, with FD60S fire doors fitted to the stairway and between the lobby and balcony.

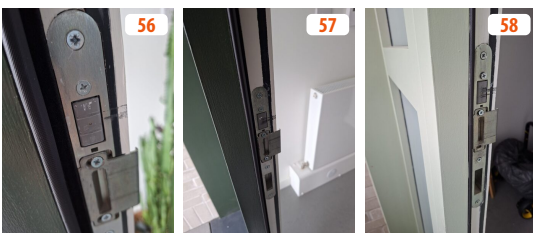
REFERENCE RB-IF21LW DUE 09/04/2026

Flats are fitted with FD30S self-closing fire door sets with pyro glass side panels. The doors are fitted with a thumb turn internally.
 Flats opening onto open balconies with a single direction of escape are required to be fitted with at least FD30 fire doors, fitted with suitable self-closing devices.

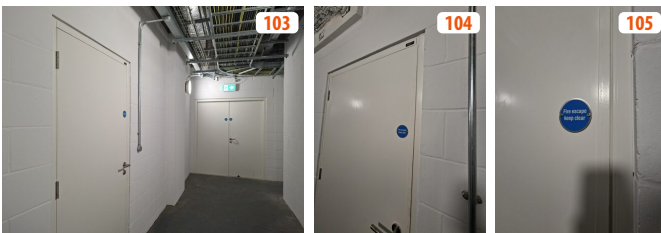
REFERENCE RB-49H182 DUE 12/06/2026

The provision of directional signage and illuminated signs is generally considered to be satisfactory.

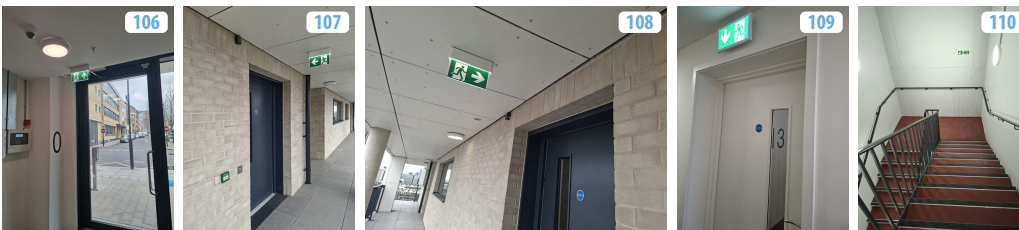
Wayfinding Signage for firefighters is installed in the lift lobbies and the firefighters staircase.

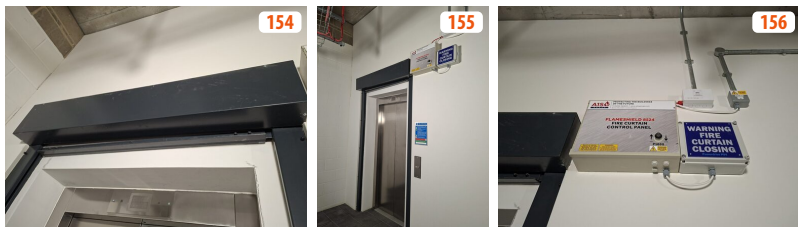
REFERENCE RB-61711K DUE 12/06/2026

A 60-minute fire and smoke shutter/curtain is fitted in front of the lift at the basement level.

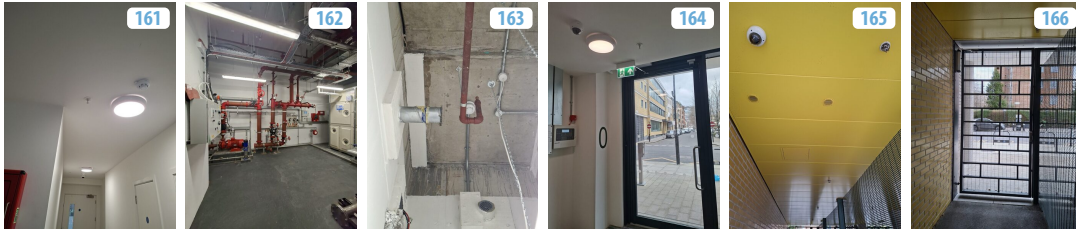
Sprinkler systems are installed throughout the flats, communal areas, plant rooms, ancillary accommodation, bin store, commercial units and undercroft area.

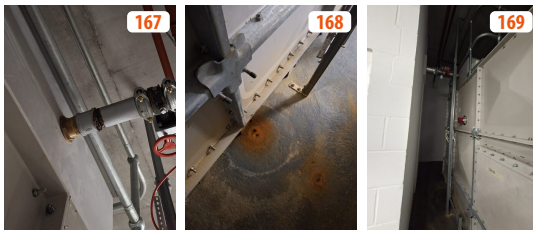
REFERENCE RB-59UPPC DUE 12/06/2026

A pipe within the sprinkler pump room was noted to be leaking. A small puddle of water was present on the floor, and corrosion was visible on the pipework, with water slowly dripping from the affected area. If left unaddressed, this may deteriorate over time and could adversely affect the reliability and performance of the sprinkler system.

Arrange for a competent person to inspect the leaking pipework and carry out any required remedial works required.

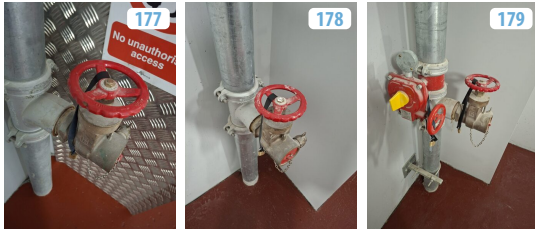
Manual AOV overrides and indicator equipment are provided for fire fighters.

Dry riser outlets were secured in position with a strap.
