Cromwell Tower

Barbican Estate, EC2Y 8DA

External Fire Risk Assessment

Prepared by: Turner & Townsend

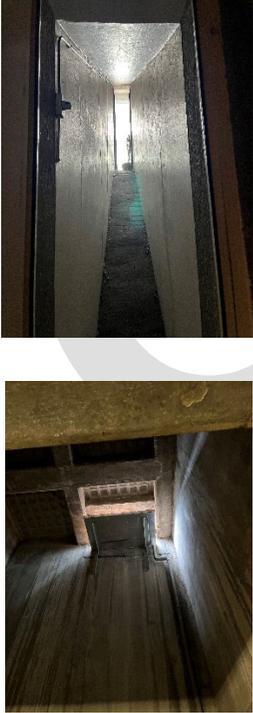
<p>signs should be mounted at the same height.</p> <p>e. The text should be on a contrasting background, easily legible and readable in low level lighting conditions or when illuminated with a torch.</p>					
<p>10.</p>	<p>In general, the smoke vents, grills and louvres etc. appear to be contaminated by an historical accumulation of dust / exhaust fumes etc. It is not clear to what extent they have been cleaned / maintained.</p> <p>The smoke ventilation in the staircase lobby appears to be open shaft with the potential to allow</p>	<p>It is advised that CoL commission an expert appraisal of the smoke control systems for the escape phase and fire-fighting phase i.e., smoke shaft(s) and permanently open smoke vents (POVs), to review their function, adequacy, condition/ status, and their planned preventative maintenance regime.</p> <p>Note – it is anticipated that such</p>

<p>smoke to pass between lobbies. The effectiveness of the current smoke control could not be confirmed as part of this Type 1 FRA.</p> <p>Also, at podium level the original door between the lift lobby and the stair appears to have been removed. The smoke ventilation shaft which on the upper floors only ventilates the lobbies however on this floor also now ventilates the lift lobby.</p>	<p>an appraisal may be considered necessary as part of the Safety Case required under the Building Safety Act 2022. This should consider if the removal of the door at podium level has any detrimental impact on the original smoke ventilation strategy.</p>					
<p>11.</p>	<p>It is understood that periodic flat entrance door and communal fire door inspections are being completed as required by the</p>	<p>It is advised that fire doors (including flat entrance doors) are asset tagged with electronic inspection records maintained to</p>		<p>Low</p>	<p>D</p>
