Ben Johnson House

Barbican Estate

External Fire Risk Assessment

Prepared by: Turner & Townsend

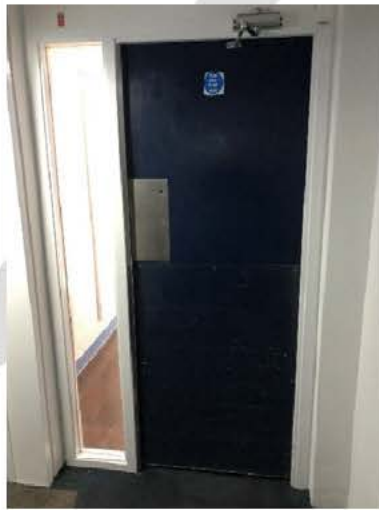
Fire doors to the stairway lobbies and stairs were generally found to be warped and/ or have ineffective self-closers. Some of the doors are fitted with “slam pads” which prevent the doors fully closing and are likely to have warped the doors over time. It is understood that City of London plant to replace all the communal fire doors, including riser doors, with certified fire door sets. **See Action 1**

Ref No. Location:	Observations	Recommended further action	Observation Pictures	Risk Rating Low Medium High	Priority Level (please refer to table 1)	Action by Whom & When (Person task with action by premise controller	Date Completed
1	<p>Communal Fire Doors</p> <p>Fire doors to the stairway lobbies and stairs were generally found to be warped and/ or have ineffective self-closers. Some of the doors are fitted with “slam pads” which prevent the doors fully closing and are likely to have warped the doors over time.</p>	<p>Ensure all the fire doors to the stairway lobbies/ stairs are checked and where necessary the doors are eased and adjusted to ensure they fully self-close into their frames when released from any angle. Any gaps between the door and frame should be a maximum of 4mm.</p> <p>The door condition should then be monitored via the 3-</p>

It is understood that City of London plant to replace all the communal fire doors, including riser doors, with certified fire door sets.	month fire door check required under the Fire Safety (England) Regulations.					
2	Emergency Lighting The emergency lighting in the building appears to be provided by a mix of self-contained units and "Standby Lighting" (as defined by BS5266 Part 1) with an alternative power supply provide by a generator. It was not possible to confirm the full locations of the standby units and the adequacy of	It is advised that a site wide survey should be undertaken of the stand by emergency lighting systems in the building (and along external means of escape) by a competent person, to assess their adequacy with a "gap analysis" between the as installed standards and those required by BS5266 Part 1 2016.		Medium	D

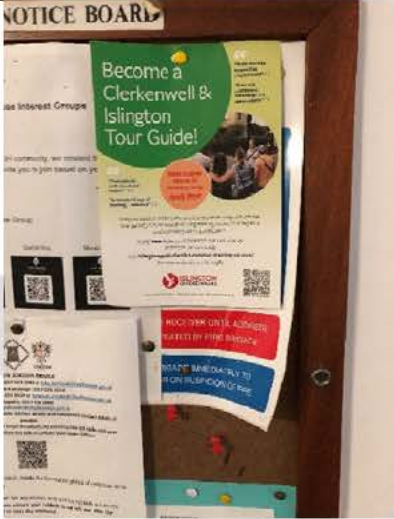
Fire Action Notices The Fire Action Notices do not describe the Stay Put strategy. At least one Fire Action Notice was partially obstructed by other notices. **See Action 4**

4	<p>Fire Action Notices</p> <p>The Fire Action Notices do not describe the Stay Put strategy.</p> <p>At least one Fire Action Notice was partially obstructed by other notices.</p>	<p>The Fire Action Notices should be replaced with signs that describe the Stay Put Strategy.</p> <p>Fire Action Notices should at least be displayed at all the entrances to the building.</p> <p>It is understood this will be completed as part of the CoL signage project.</p> <p>Ensure Fire Action Notices are displayed at all entrances to the building and that all Fire Action Notices are visible and not obstructed by other notices.</p>

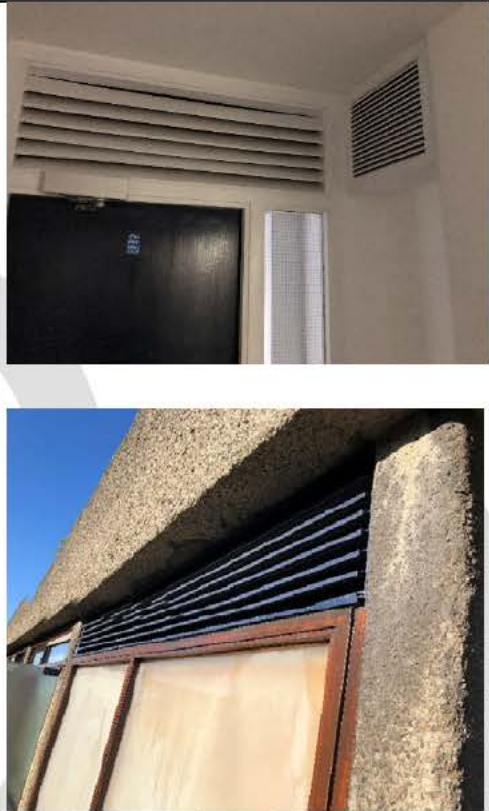
It is not known if the arrangement of Permanently Opening Vents in the corridors and lobbies would be effective. It could also not be confirmed if the vents have been periodically cleaned / maintained. **See Action 5**

Low	D		
5	<p>Smoke Ventilation</p> <p>It is not known if the arrangement of Permanently</p>	<p>If not previously completed it is advised that CoL commission an expert appraisal of</p>		Low	D

<p>Opening Vents in the corridors and lobbies would be effective. It could also not be confirmed if the vents have been periodically cleaned / maintained.</p>	<p>smoke control in this building.</p> <p>The smoke control appraisal should review the smoke control systems adequacy (i.e. Permanently Opening Vents), condition and the planned preventative maintenance regime.</p> <p><i>NB – it is anticipated that such an appraisal may be considered necessary as part of the Safety Case required under the Building Safety Act 2022.</i></p>

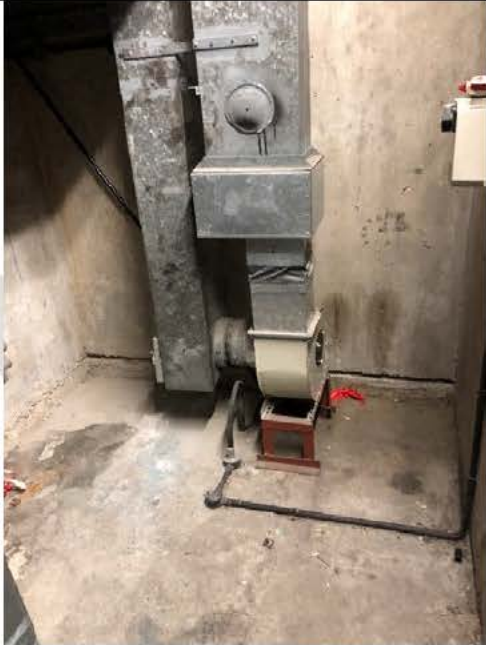
The building is fitted with a communal ventilation system(s). It is understood that these systems link between all flat bathrooms and kitchens and are therefore a potential source of smoke/fire spread between flats. It could not be confirmed if suitable shunt ducts or dampers are fitted in the system and maintained. **See Action 18**

18	<p>Communal ventilation system</p> <p>–</p> <p>The building is fitted with a communal ventilation system(s). It is understood that these systems link between all flat bathrooms and kitchens and are therefore a potential source of smoke/fire spread between flats. It could not be confirmed if suitable shunt ducts or dampers are fitted in the system and maintained.</p>	<p>It is advised that a survey of the communal ventilation systems is undertaken by a competent person to appraise whether the system incorporates suitable features to restrict the risk of smoke spread between flats, and whether any remedial measures are necessary.</p> <p><i>NB – it is anticipated that such an appraisal may be considered necessary as part of the Safety Case required under the Building Safety Act 2022.</i></p>
